TEST REPORT No.: INZ58565-08A

Client: Fastmount Limited
Order No.: TBD
Sample Description: Low Profile Range
Identification: As listed below
Material Specification: Acetal copolymer
Tested in accordance with: Client instruction

Test: SGS NZ was engaged by the client to carry out a repetitive pull-out load test (Fig.1) and a shear test (Fig. 2) on the Fastmount Low Profile Range plastic mounting systems in various configurations.

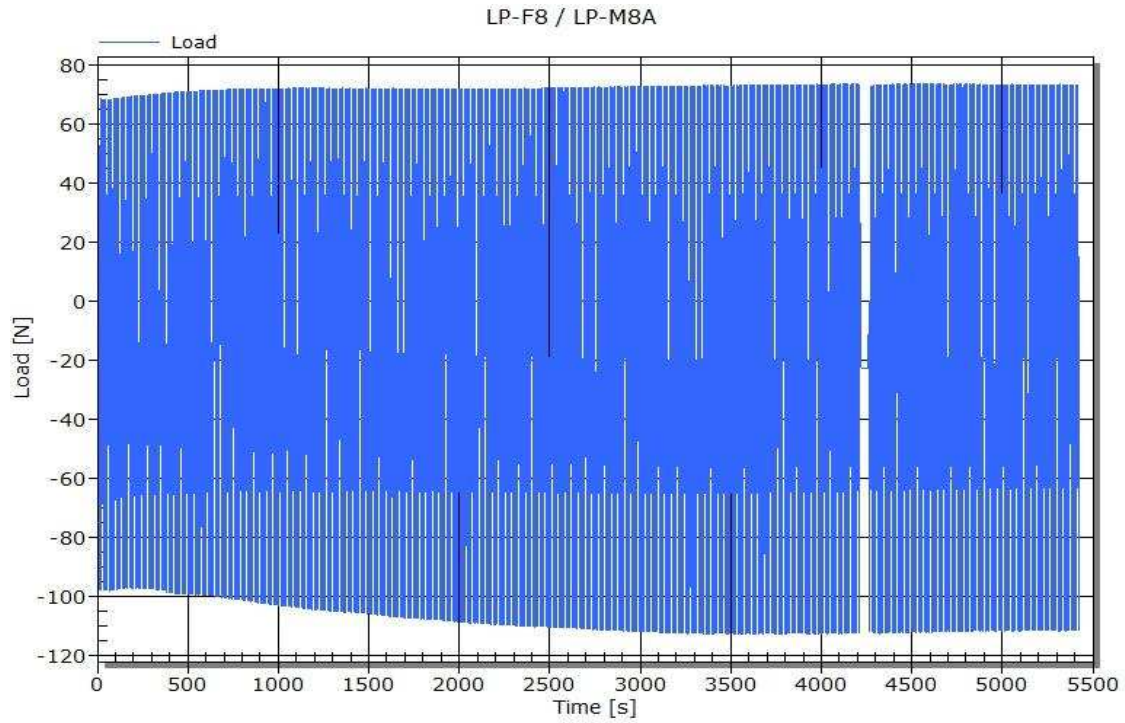
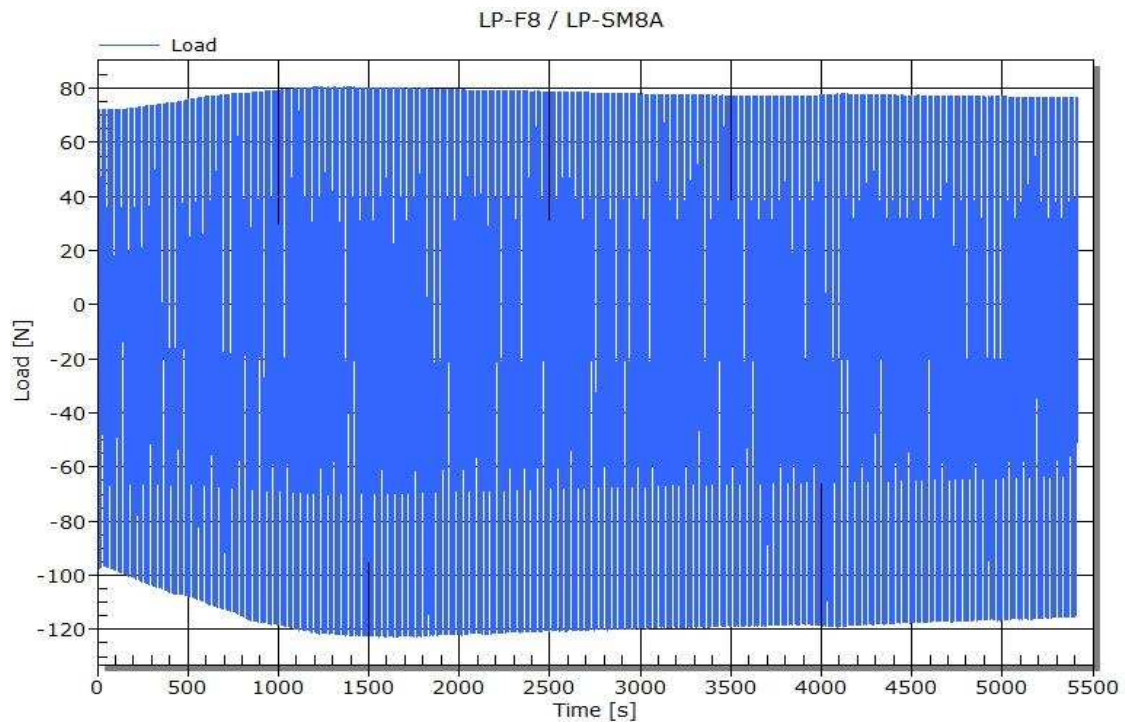
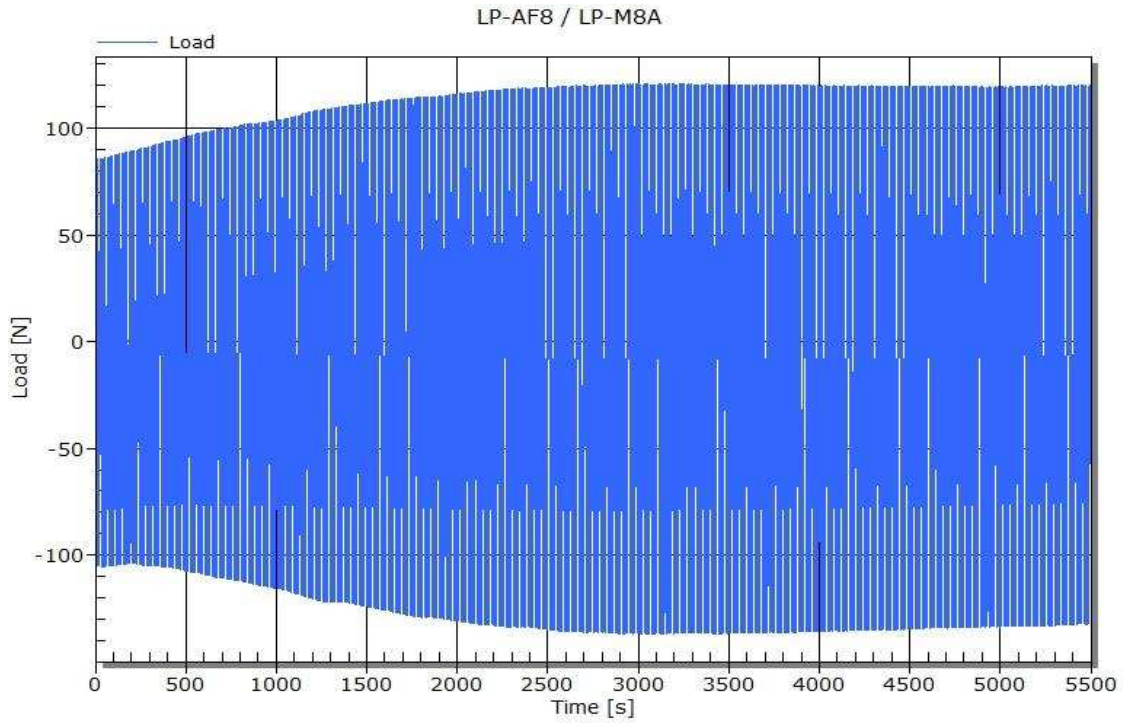
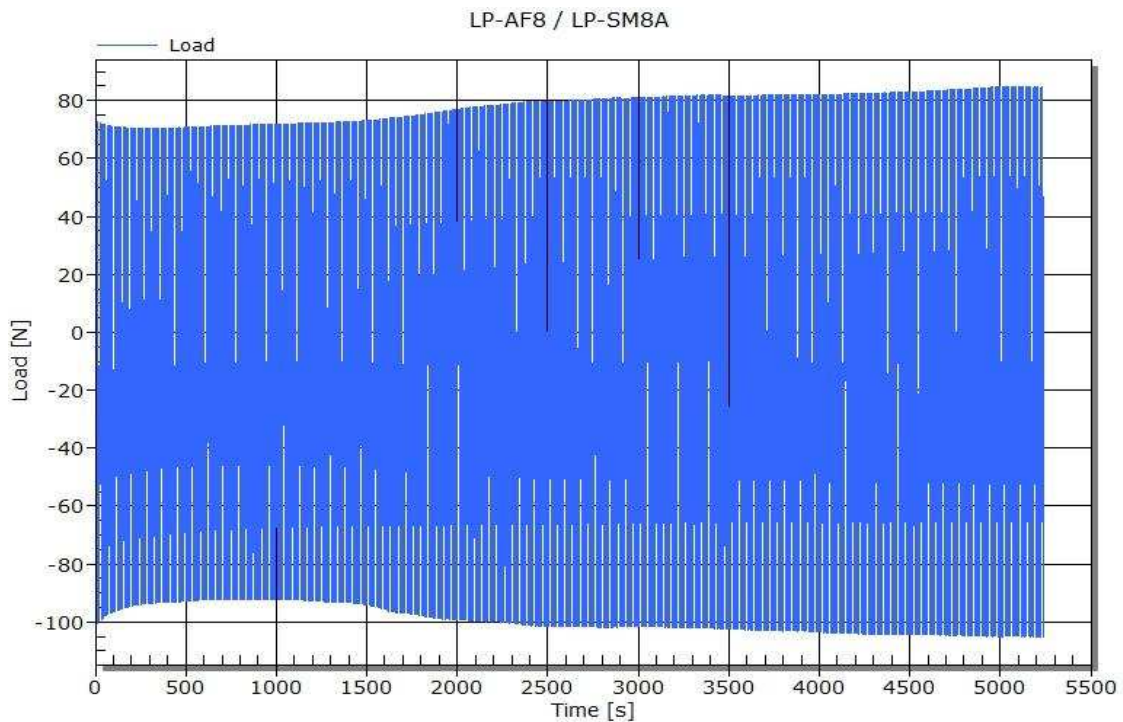
Appendix B - Graphical representation of repetitive pull-out test data

Female / Male Clip	Pull-out Force (Kgf)		Shear Force (Kgf)	Shear Failure Location
	Initial	After 500 Cycles		
LP-F8 / LP-M8A	7.0	7.4	104.7	Male clip pulled out of mandrel
LP-F8 / LP-SM8A	7.4	7.8	56.9	Adhesive
LP-AF8 / LP-M8A	8.7	12.1	136.9	Male clip
LP-AF8 / LP-SM8A	7.4	8.7	105.3	Adhesive
LP-DF8 / LP-M8A	8.3	7.8	88.0	Male clip pulled out of mandrel
LP-DF8 / LP-SM8A	8.4	8.9	62.6	Adhesive
